LINCOLN ARCHAEOLOGICAL STUDIES No. 4

The Archaeology of the Lower City and Adjacent Suburbs

Kate Steane

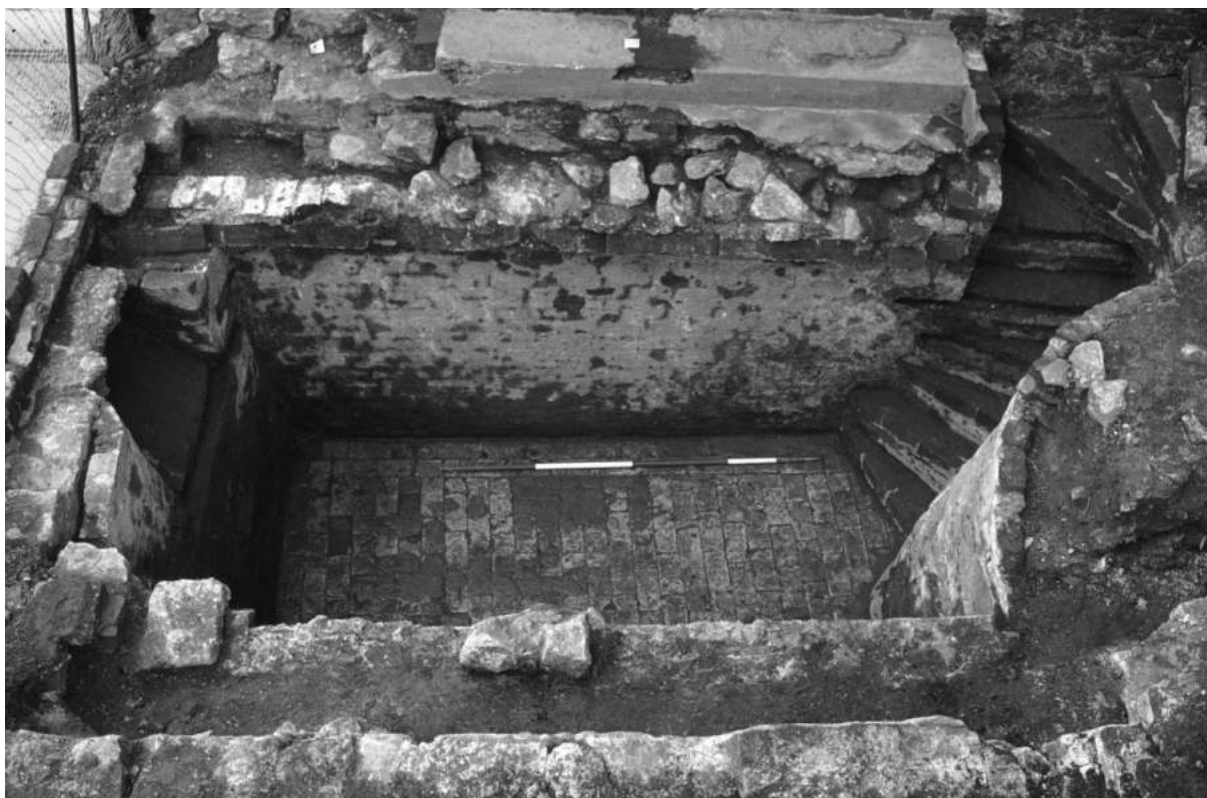
Fig. 9.34. Brick-lined cellar cg248 of Structure 11: LUB 42. Looking south.

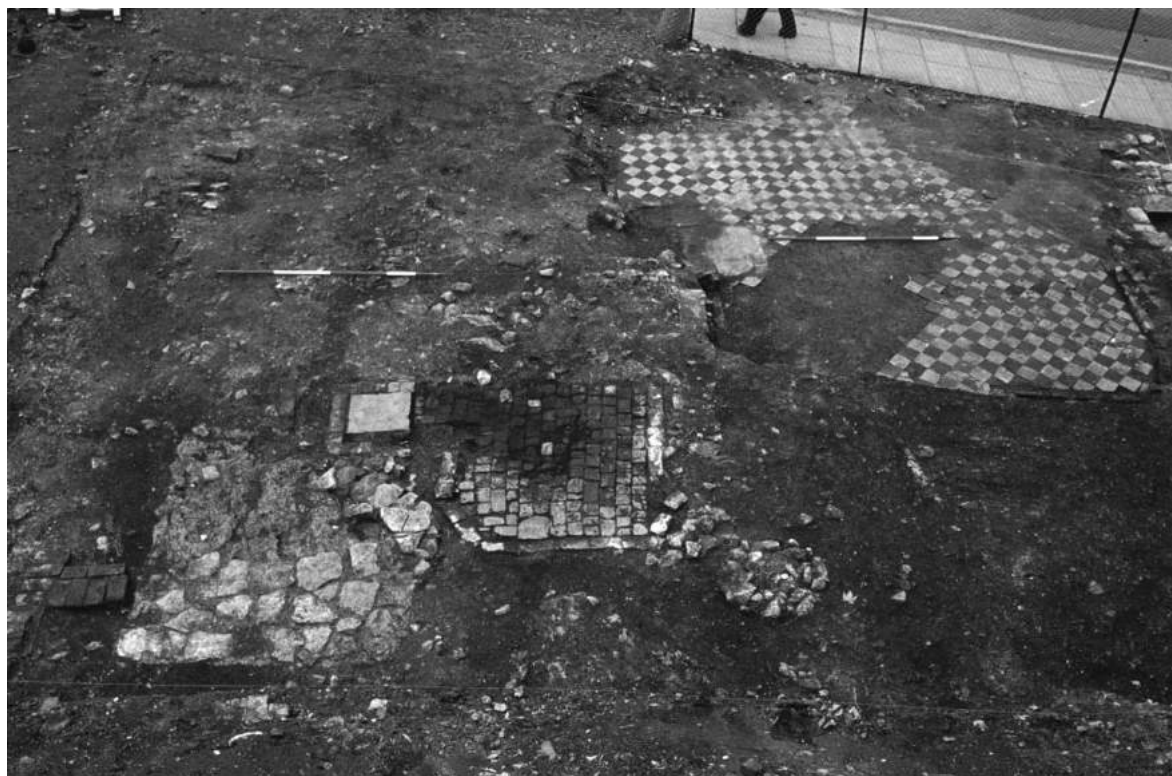
Fig. 9.38. Looking east at the remains of Structures 12 (to left) and 13 (centre); tiled floor cg279 of Structure 15 top right: LUBs 47, 49 and 51.

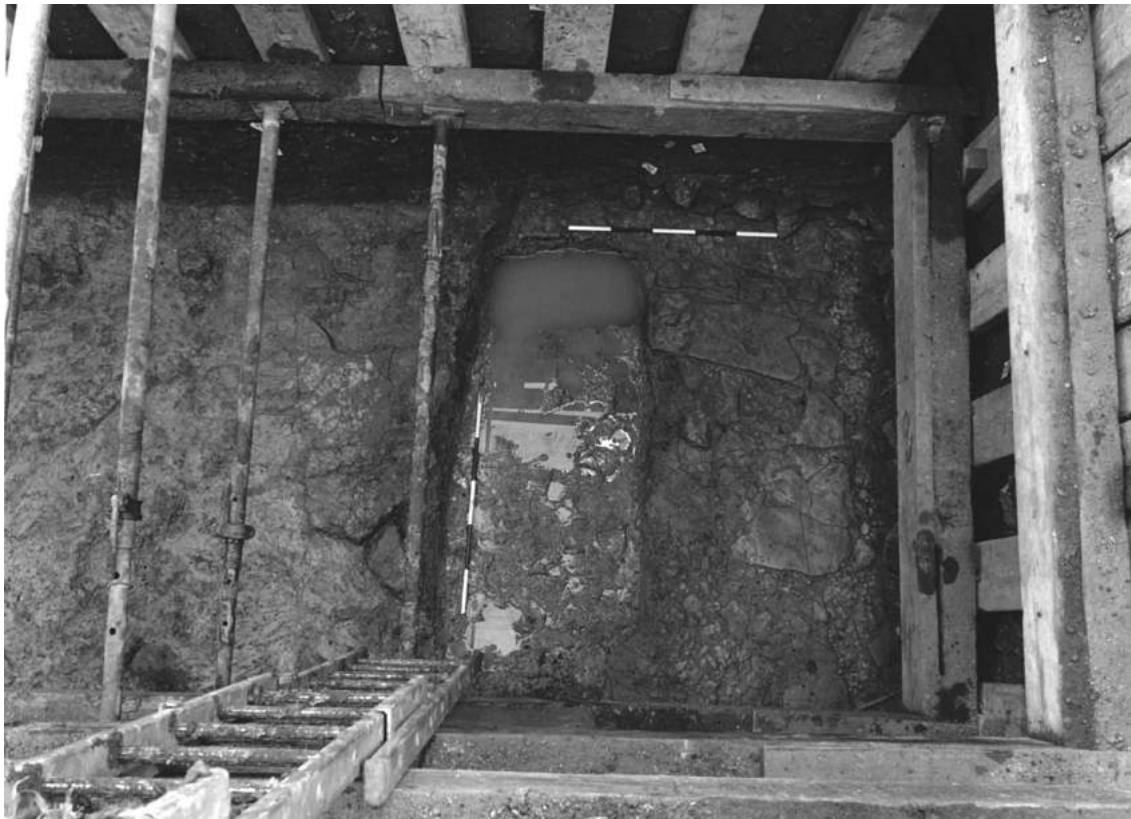
Fig. 10.31. Trench 2, looking down at stone paving cg67 in the bottom of the trench; the surface can be best seen far right. The large pit in the middle is the robber trench cg93 of the west wall of Structure 3: LUBs 2 and 18.

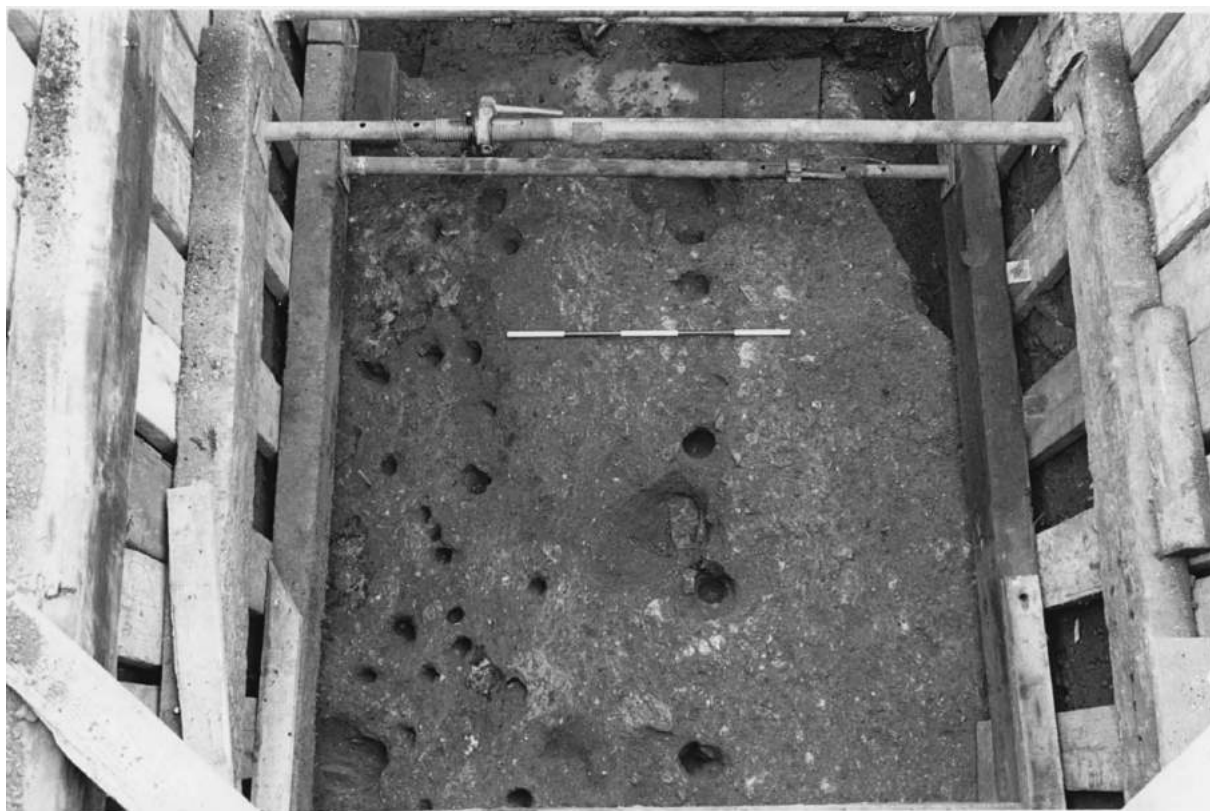
Fig. 10.32. Trench 2, stake-holes associated with Structure 6.2 (cf Fig 10.13): LUB 27. Looking west.

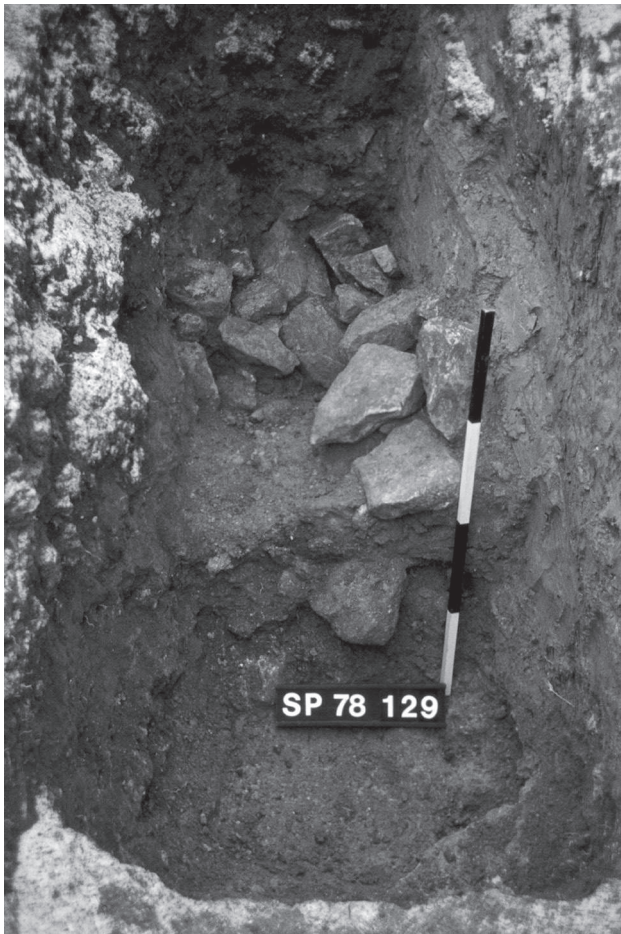
Fig. 11.9. Trench 4, looking west at terrace wall foundations cg74 (Structure 8): LUB 19.

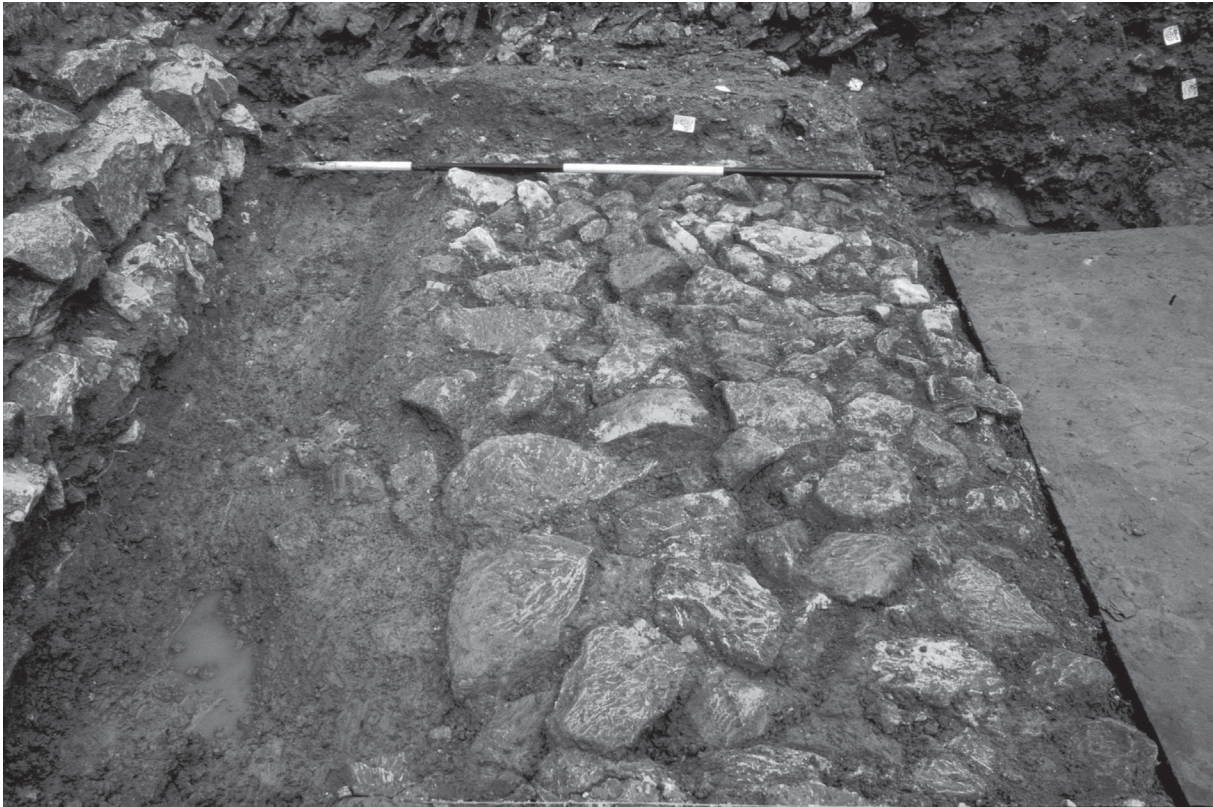
Fig. 12.18. Looking north at street surface cg42, cut away to the left for the construction of walls cg56: LUBs 4 and 9.

On the western frontage of the street was a stone building, Structure 5.1 (LUB 9; Fig. 12.18), apparently constructed in the early part of the 4th century. In Area A, at the western end of the site, Structure 6 (LUB 14) with at least four rooms, was probably built after Structure 5.1. Since only part of each structure was found, and there was an unexcavated gap between them, it is difficult to know if they represented the original elements of larger structures or were part of the same one (see below). It does, however, seem likely that Structure 5.1 was an original element since it fronted the street to the east. There may have been a further street to the west of the site onto which Structure 6 might have fronted.

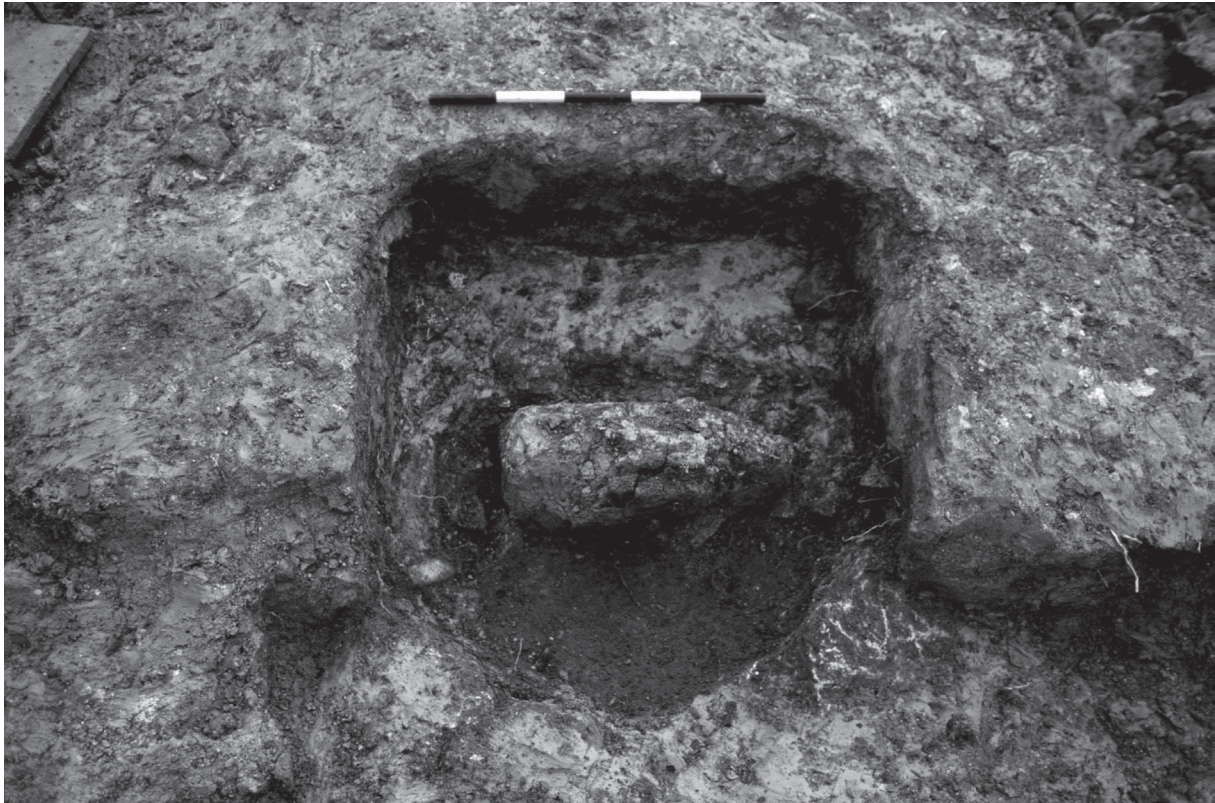
Fig. 12.19. Pit and clay pad cg52: LUB 6. Looking east.

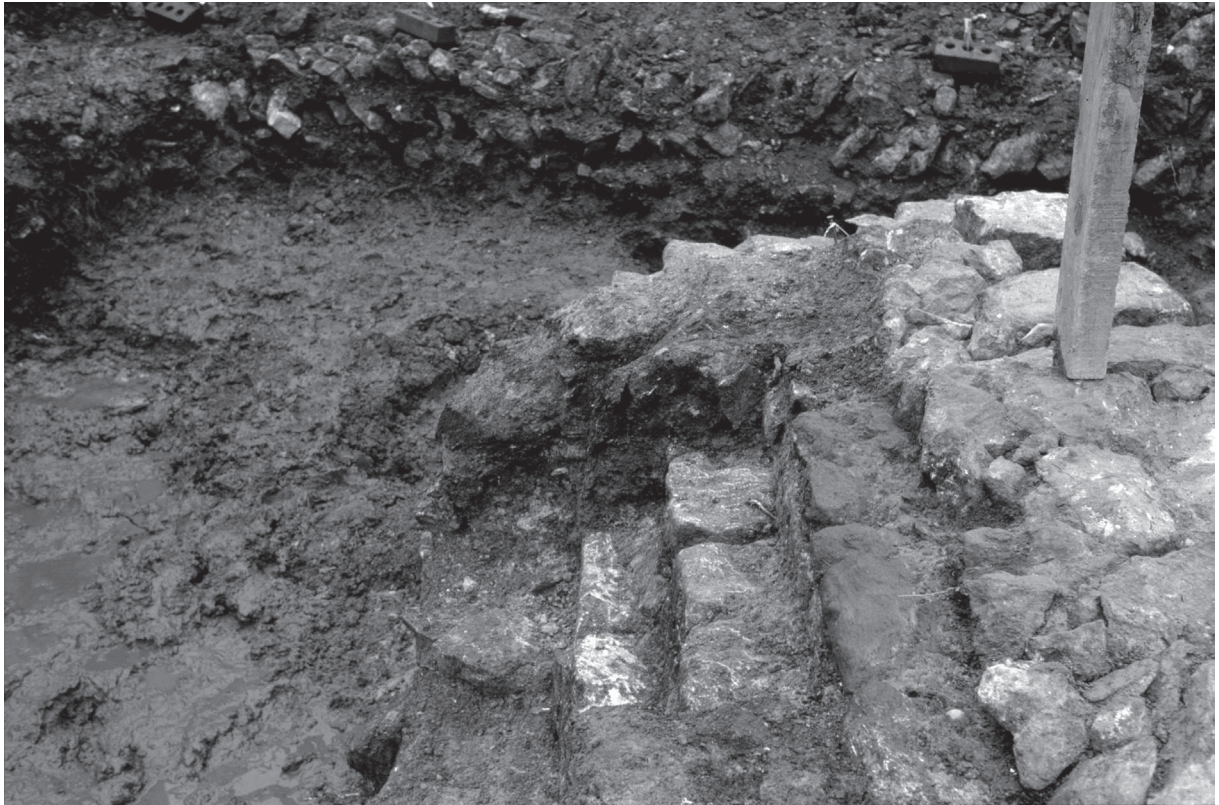
Fig. 12.20. Structure 5, looking north at internal offsets of wall cg56: LUB 9.

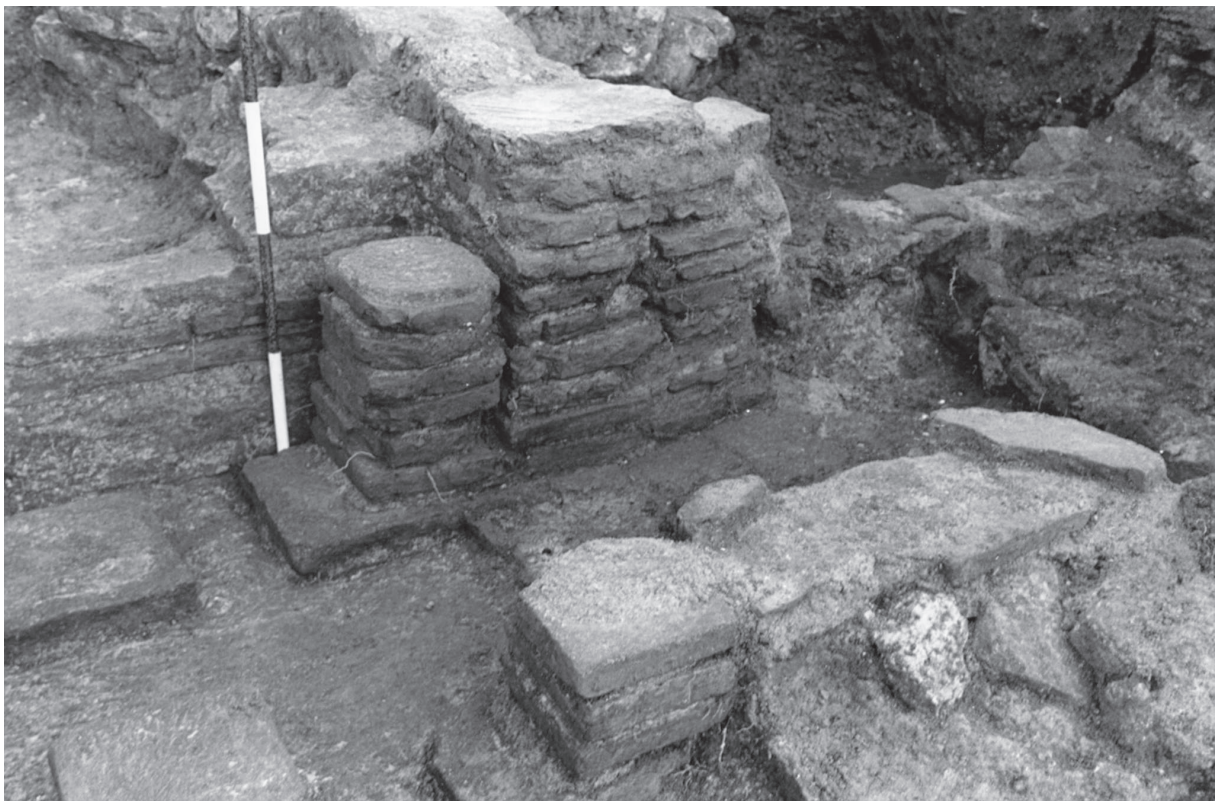
Fig. 12.21. Structure 5, the tiled flue cg115 between the hypocaust (room 5.2C, left) and the furnace (room 5.2A, right): LUB 17. Looking north-east.

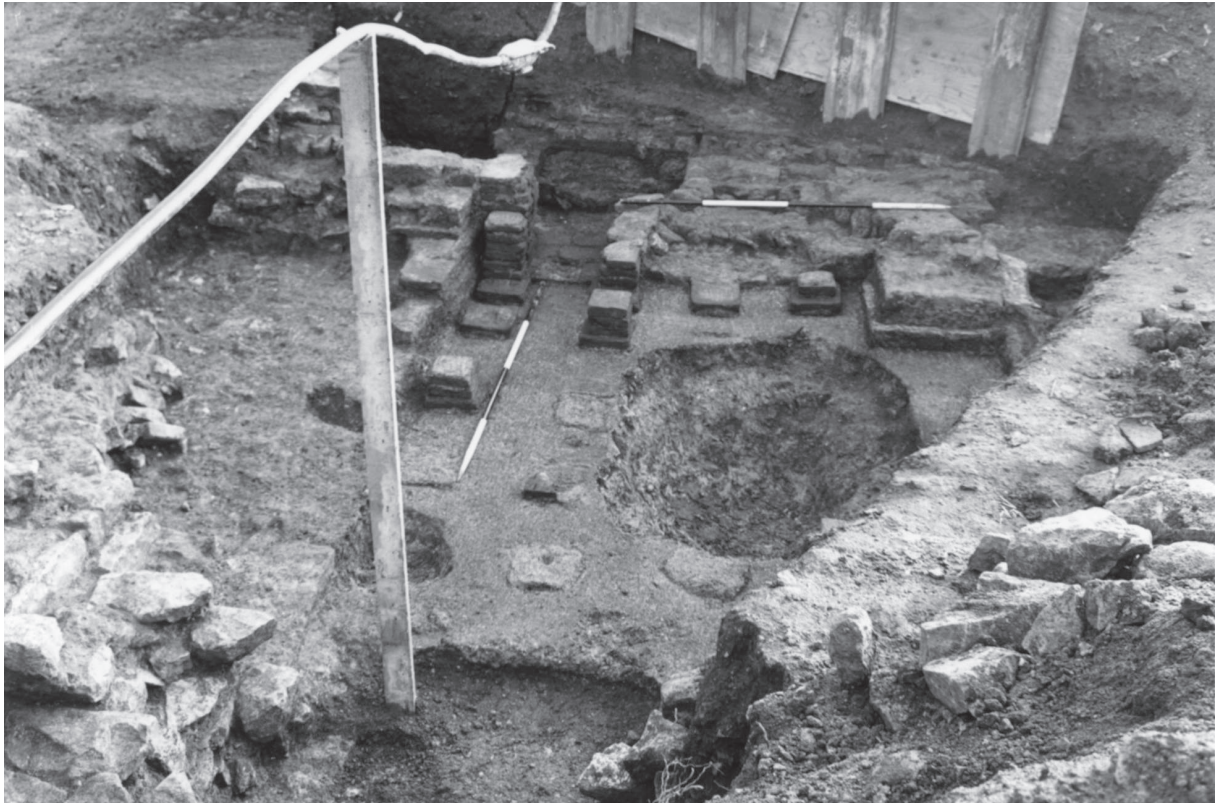
Fig. 12.22. Structure 5, looking east-north-east at hypocaust (room 5.2C), and furnace area (room 5.2A) beyond: LUB 17; modern service cable dangles over the trench.

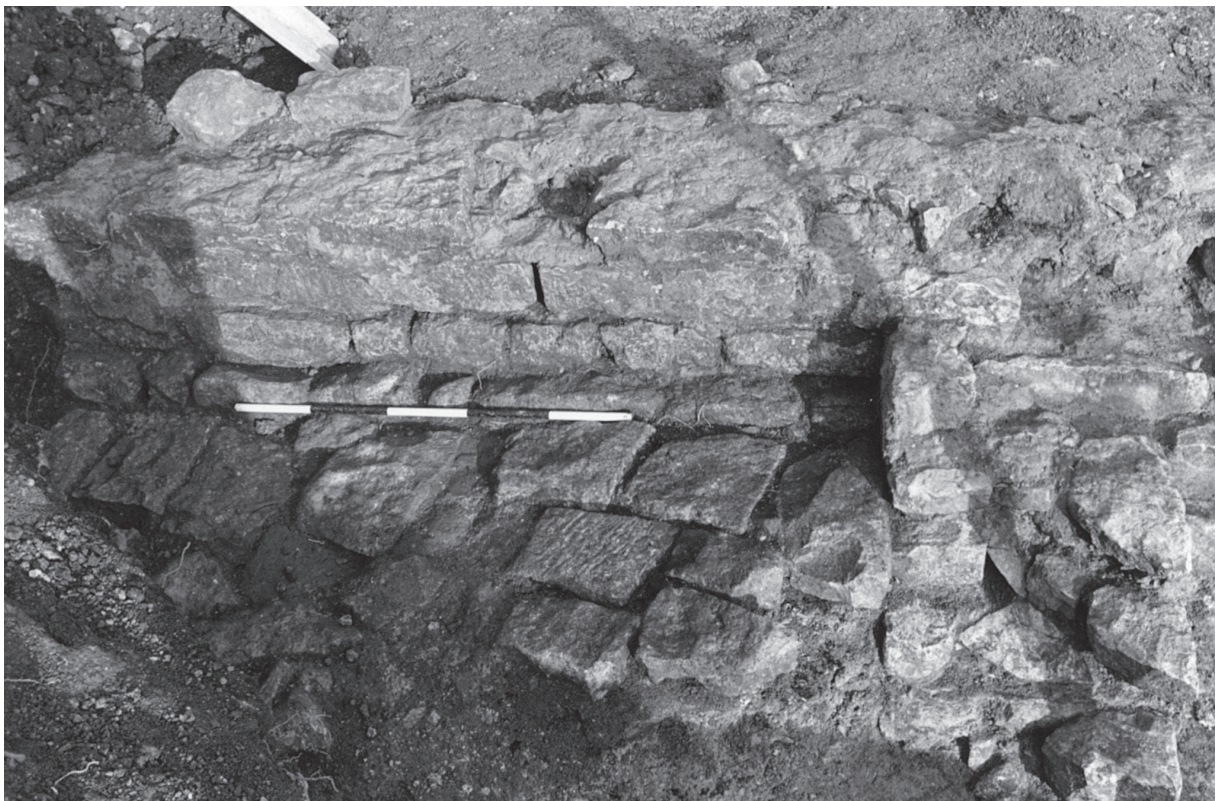
Fig. 12.23. Structure 5, wall cg117 and limestone slabs cg119 (room 5.2D): LUB 17. Looking north.

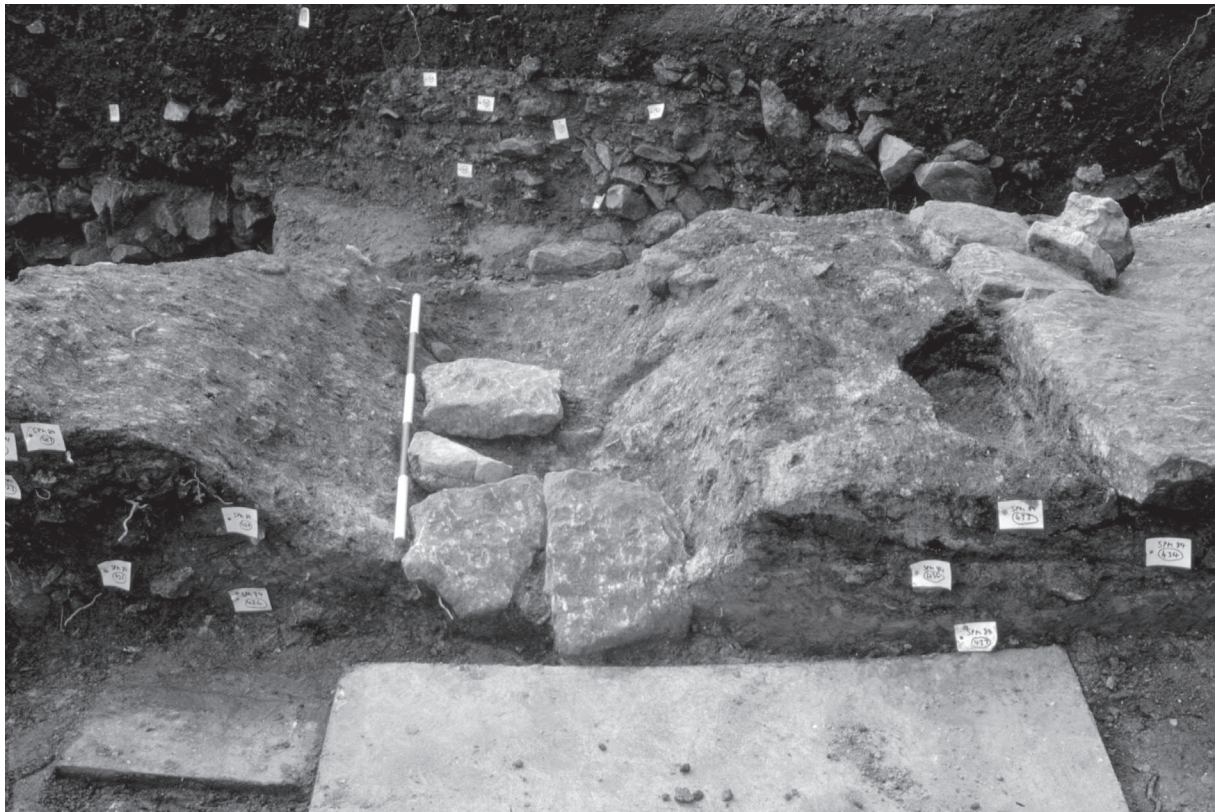
Fig. 12.24. Structure 5, looking south at robber trench cg104 of wall cg53: LUB 18.

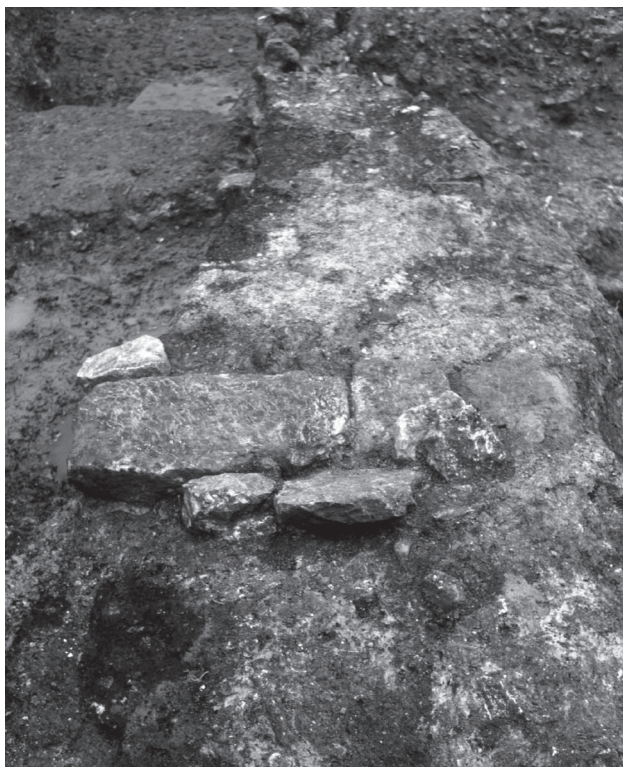
Fig. 12.25. Remains of north-south partition cg105 in room 5.2A: LUB 18. Looking east.

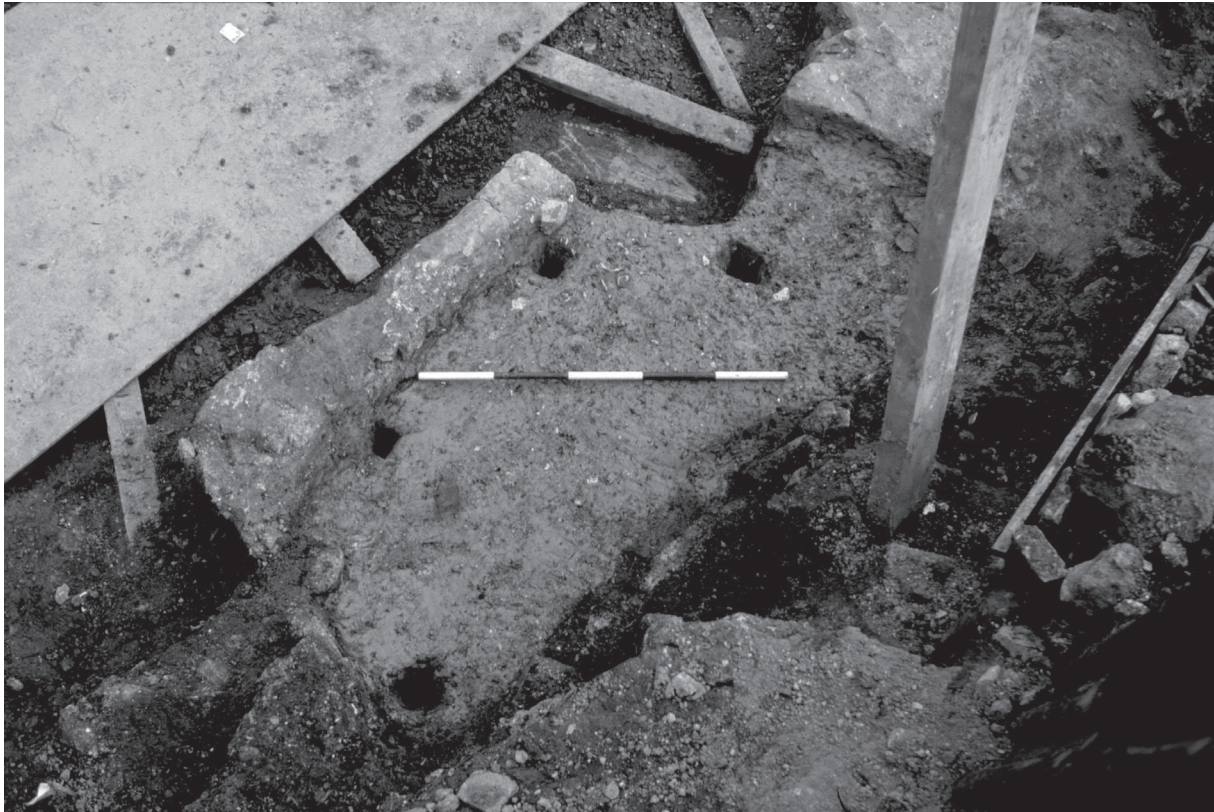
Fig. 12.26. Pit with stake-holes cg129 in room 5.2A: LUB 18. Looking south-east.

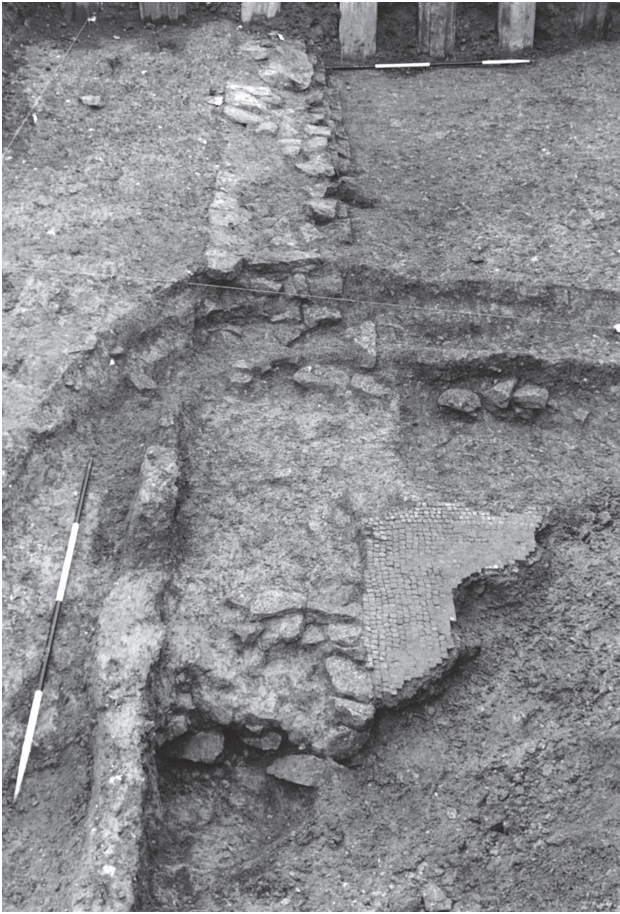
Fig. 12.27. Looking east at wall cg145 of Structure 6 cut by gully cg154: LUB 22. This wall and wall cg146 were later robbed, leaving only a small fragment of the tessellated pavement in situ (cf Fig. 12.28).

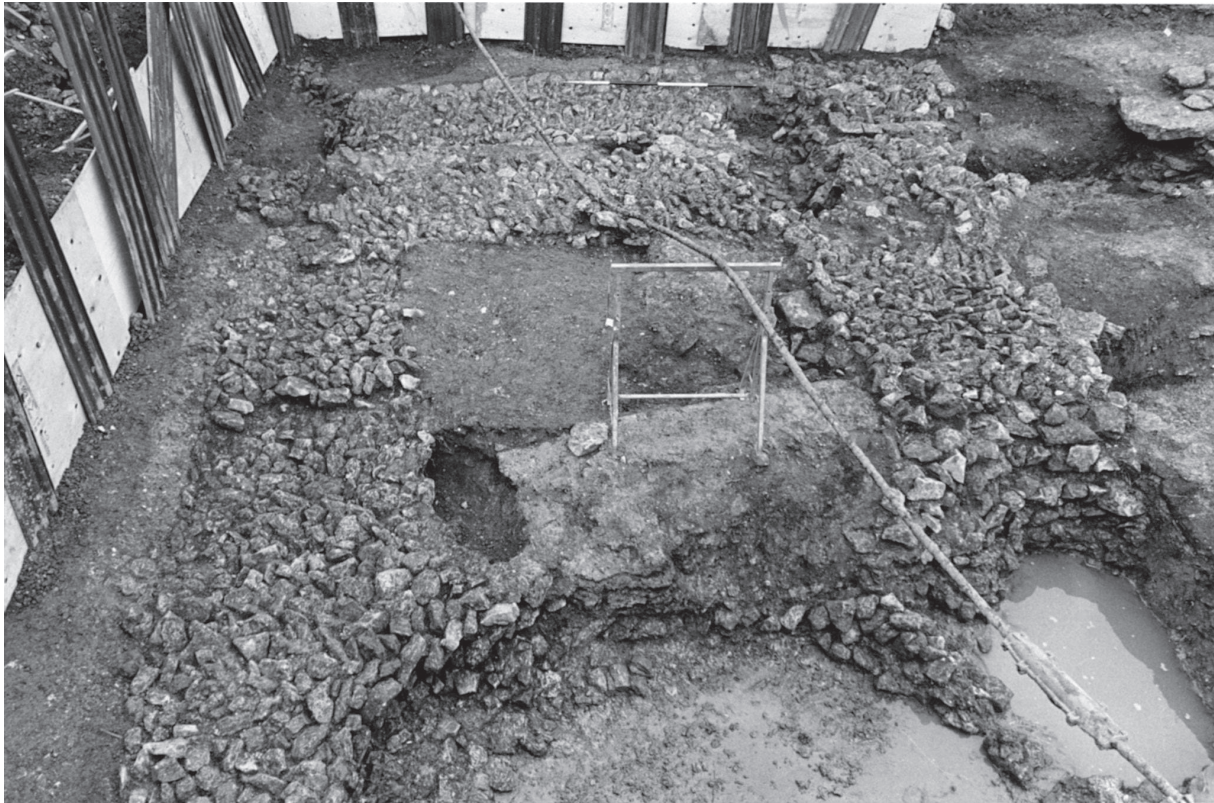
Fig. 12.29. Looking east at wall foundations of the added west tower of the church of St Peter Stanthaket (foreground) and the western end of the nave beyond: LUB 30. Later pits (LUB 37) had disturbed some of the west wall of the tower.

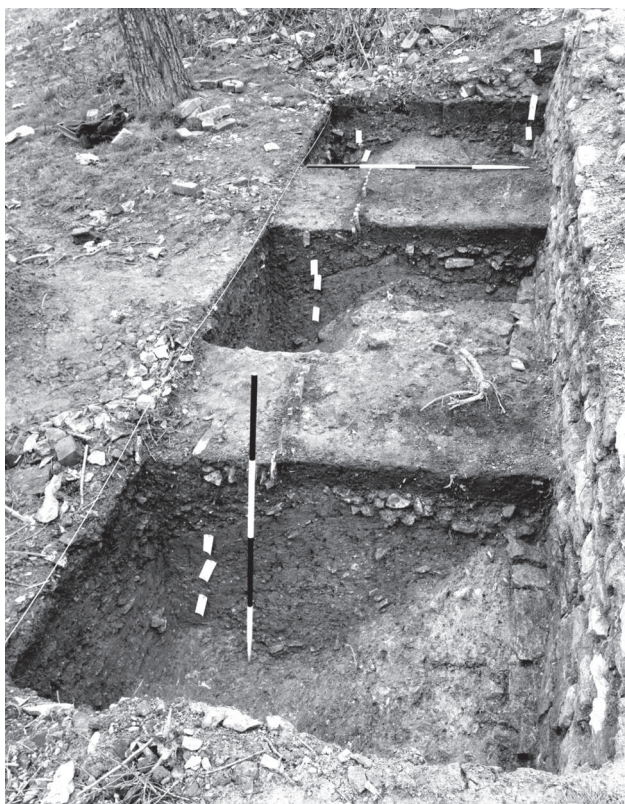
Fig. 13.10. Looking north at partially excavated ditch fill cg6, with the truncated wall cg7 on the right, under Motherby Hill pathway: LUBs 3 and 4.

Cutting features cg1, cg2, cg3, cg5 and cg10 (LUBs 1 and 2), and visible in all three trenches (*ie* for at least 7m) was a north–south ditch cg6 with various fills, mainly of loam and clay with stones (Fig. 13.10). It was at least 1.8m wide and 0.95m deep. Its edge deviated slightly, but this may have been due to subsequent erosion. The ditch cutting itself cannot be precisely dated, but post-dated the 10th–11th centuries (LUB 2).

The stratigraphy was truncated in the post-medieval period when a boundary wall cg7 (Fig. 13.10) was erected. This may have been associated with the path, Motherby Hill, which was laid out as a walkway in the early 18th century.

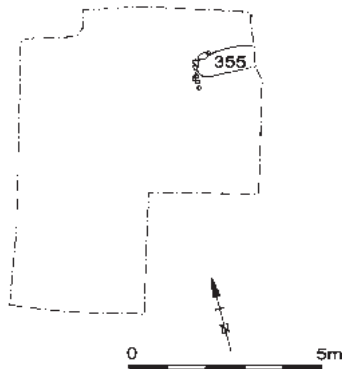
Fig. 14.36. Trench VI; burial cg355: LUB 616.

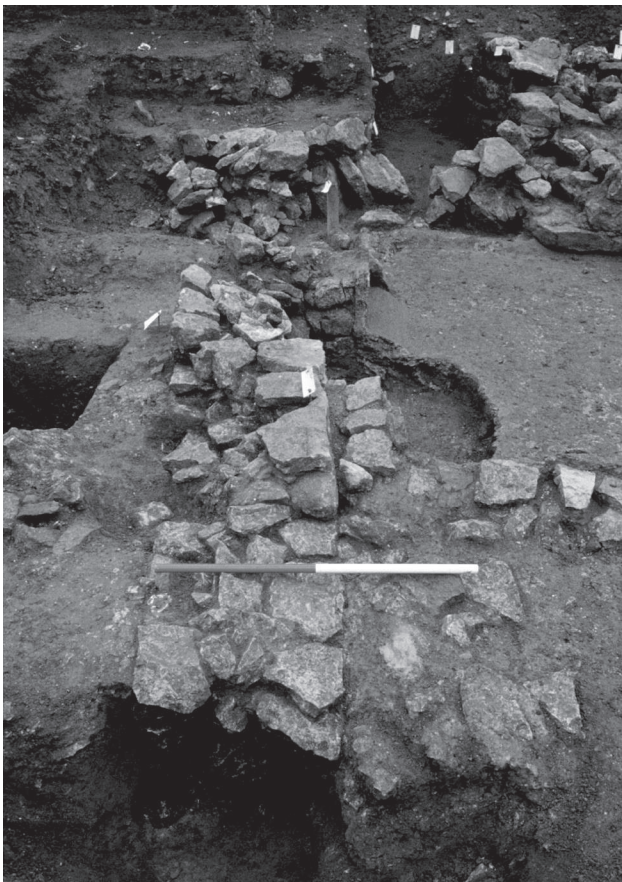
Fig. 14.53. Structure 30, wall cg323, with later walls cg503 and cg335 of Structure 32 beyond: Trench VI, LUBs 605 and 608. Looking north.

At the limit of excavation at the western side of the main trench was a north–south stone wall cg323 (0.6m wide and at least 5m long; Fig. 14.53) with a return to the west at the north end (as suggested by the section Fig. 14.49). Wall cg323 may have continued further north, but this was not clear. In the separate trench to the west, and cutting natural sand cg317 (LUB 600), were pitched limestone foundations cg331 which appear to have supported east–west and north–south walls (Fig. 14.54). The north–south foundations were about 0.7m wide, while those that ran east–west were about 1.4m wide, suggesting a very substantial wall. One possible interpretation for such an unusual thickness of wall might be the nearby presence of a hypocaust furnace (see p. 454).

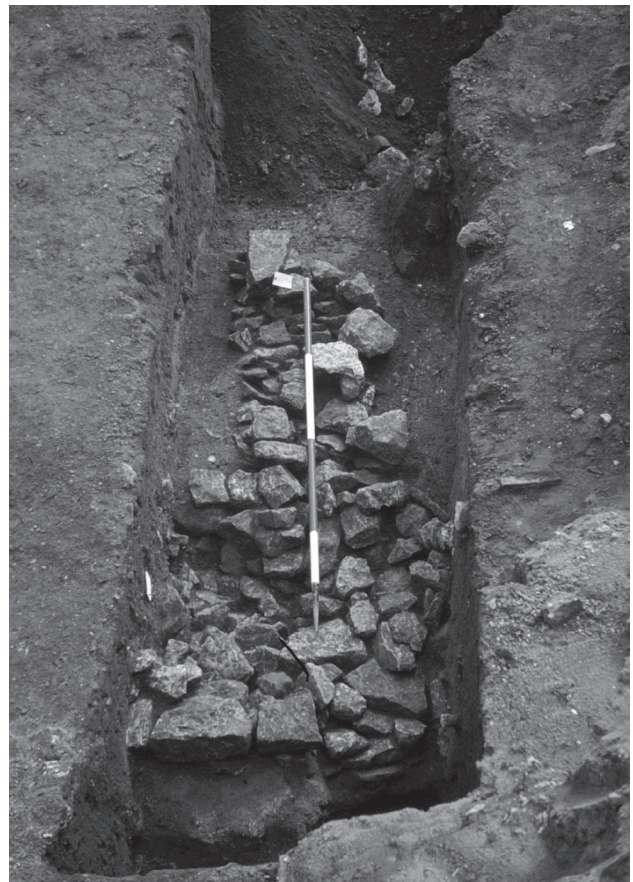
Fig. 14.54. Looking south at foundations cg331 for Structure 30: Trench VI (western extension), LUB 605.

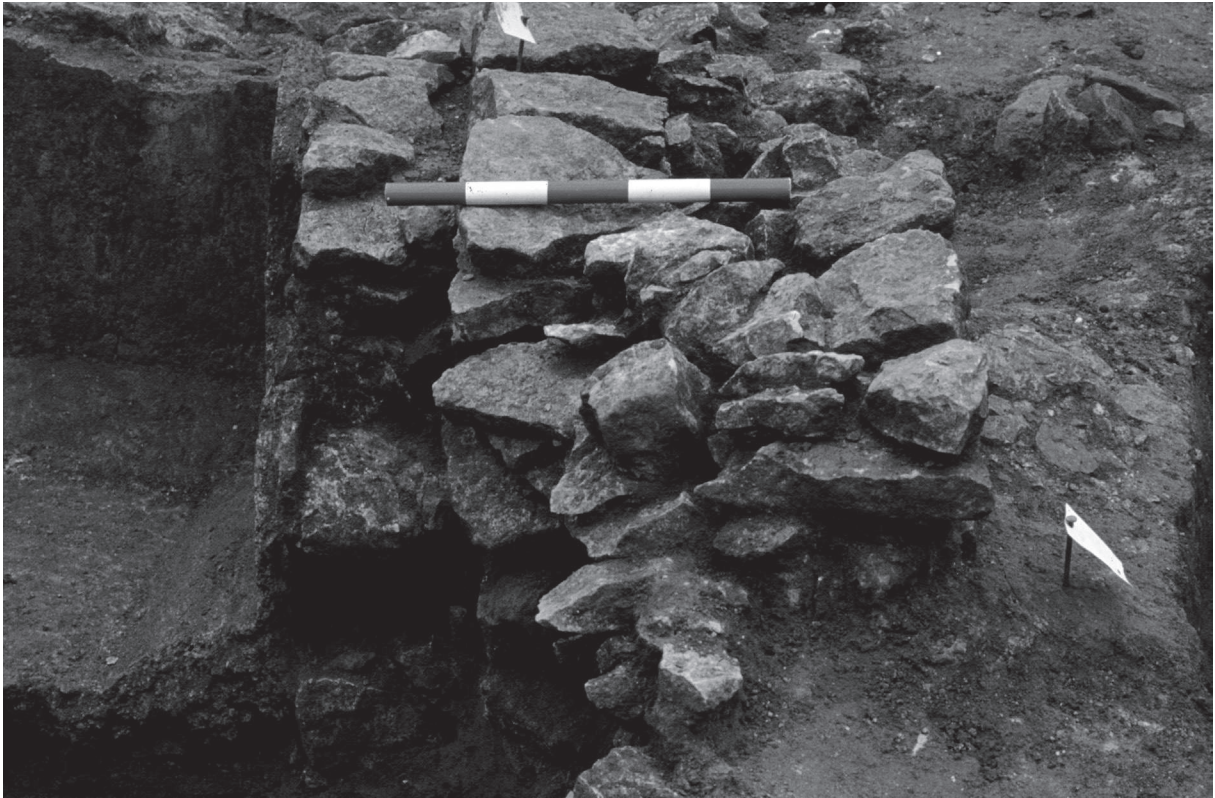
Fig. 14.55. The wall of Structure 31's cold plunge bath cg324 added to existing east wall cg323 of Structure 30: Trench VI, LUB 606. Looking south.

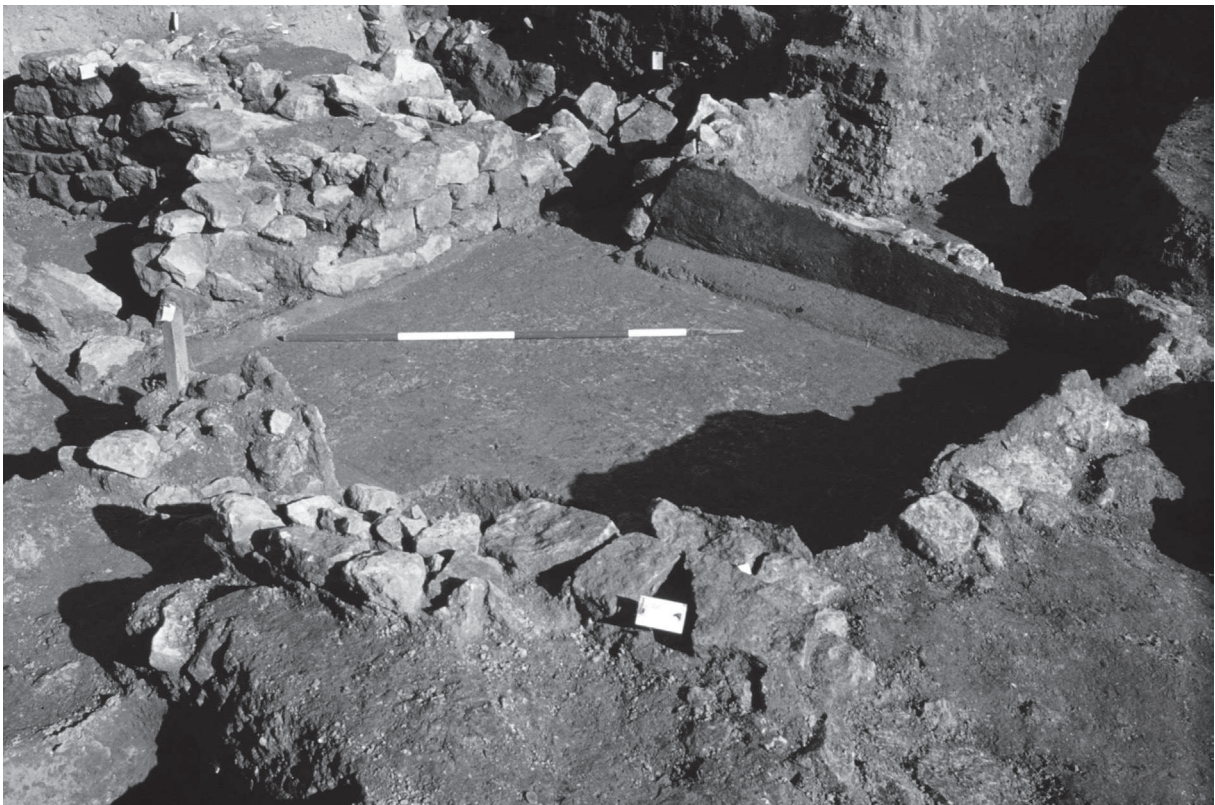
Fig. 14.56. Structure 31's cold plunge bath cg324; the north side of the bath had been cut away by wall cg503 of Structure 32: Trench VI, LUB 606. Looking north-east.

Cutting both charcoal spread cg318 (LUB 601) and the southern part of beam-slot cg321 (LUB 603), and apparently added to wall cg323 of Structure 30 (LUB 605), was a cold plunge-bath cg324, measuring 3.2m north–south by 2.6m east–west internally (Fig. 14.55) with a drain at the south-east corner. The floor and walls were lined with *opus signinum* and had a quarter-round moulding at their junction. The floor (Fig. 14.56) lay at 6.95m OD; the walls survived to a height of about 0.8m in places. The cold plunge probably formed part of a small baths-suite, Structure 31, added to the east side of Structure 30.

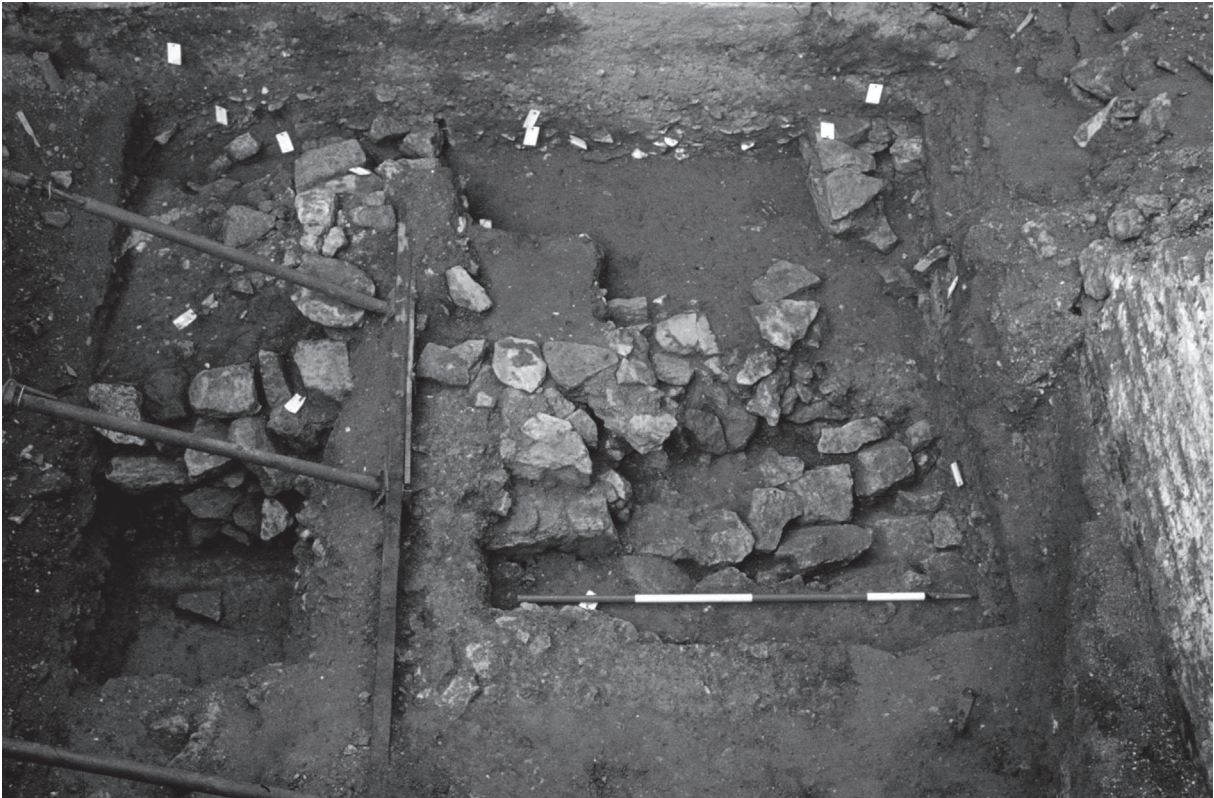
Fig. 14.57. Looking north at walls cg503, cg335 and cg333 of Structure 32: Trench VI, LUBs 608 and 609.

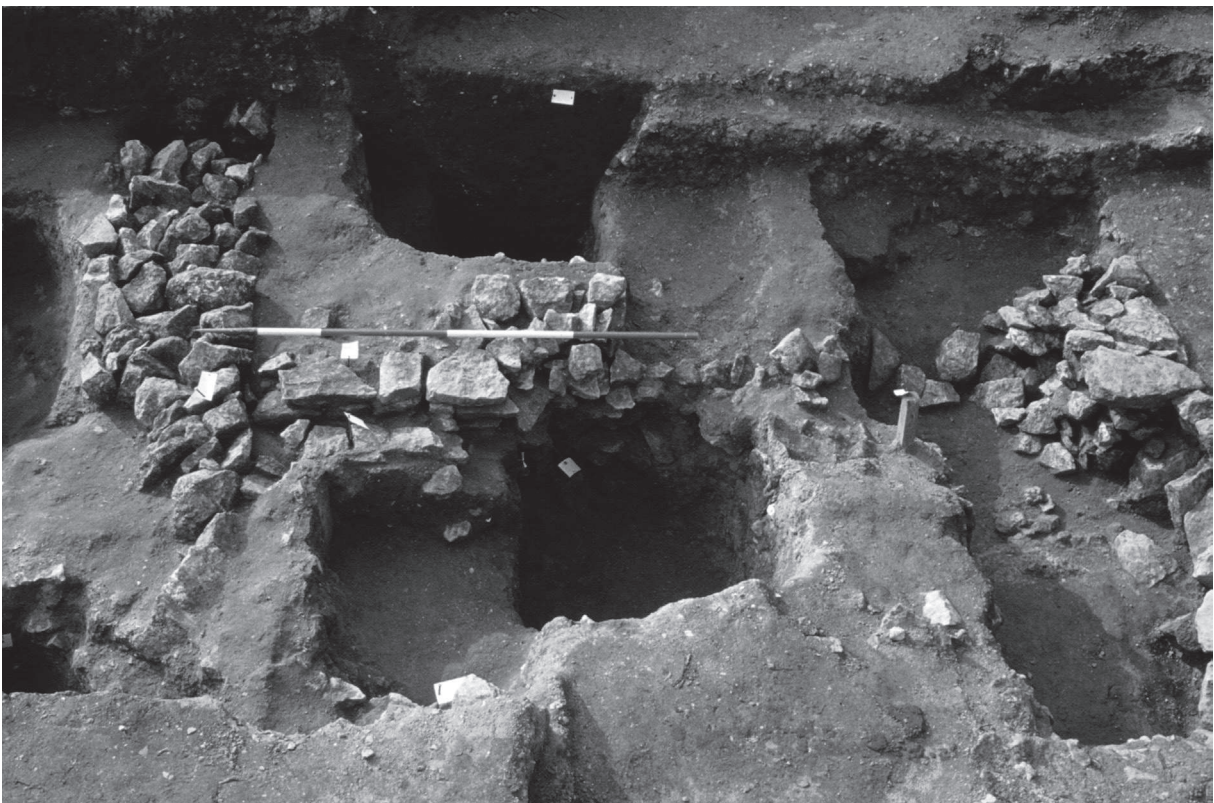
Fig. 14.58. Structure 33, walls cg332 and cg341; to the right is the line of walls cg503 and cg335 (Structure 32); in the foreground, later pits cg349 and cg350: Trench VI, LUBs 608, 609, 611, and 614. Looking west.

and reused tile, of a possible north-south wall. To its south were the pitched stone foundations cg332 (0.7m wide) of an east-west wall (Fig. 14.58); it is likely that these too cut debris cg327 (LUB 607). These north-south and east-west foundations may have represented the remains of one or more stone buildings, Structure 33. All of the pottery (12 sherds) was of Hadrianic or later date.

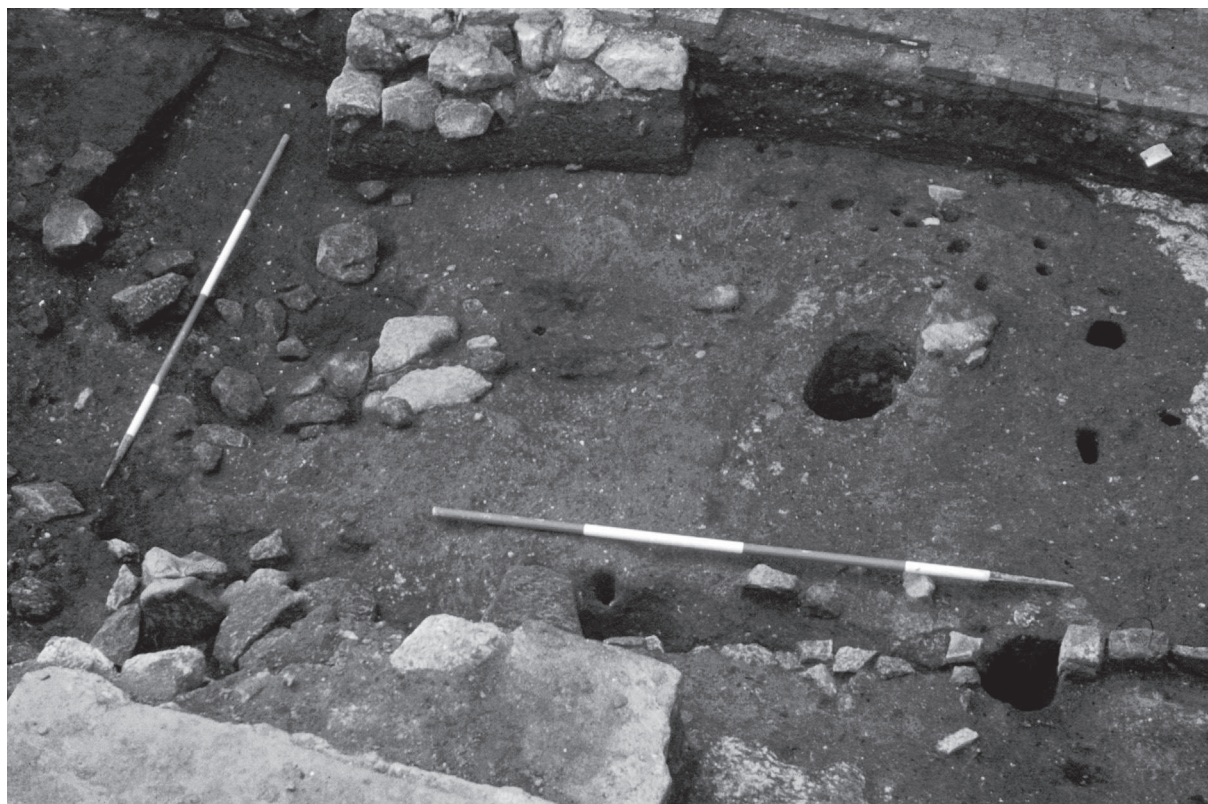
Fig. 14.60. Structure 15.3. Slot cg227 is immediately in front of the ranging pole in the middle ground, and, beyond, post- and stake-holes cg229: Trench V, LUBs 514 and 515. Looking west.

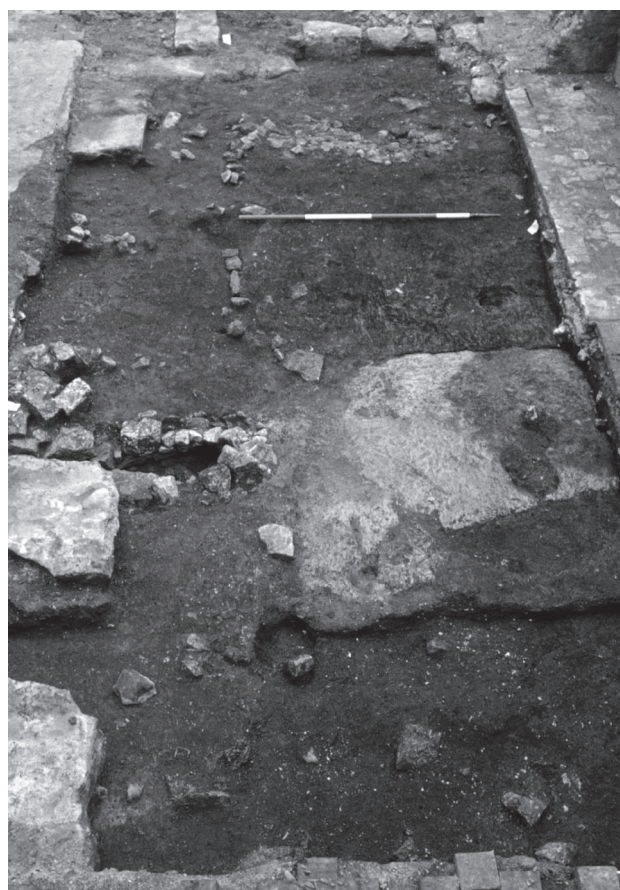
Fig. 14.61 (right). Structure 16, clay surface cg228 (looking south); later stone-lined pit cg267 (*cf* Fig 14.72) is to its left: Trench V, LUBs 521 and 535.
